SUMMARY OF AA-1 SERVICE LETTERS

SERVICE

L
E
T
T
E
R

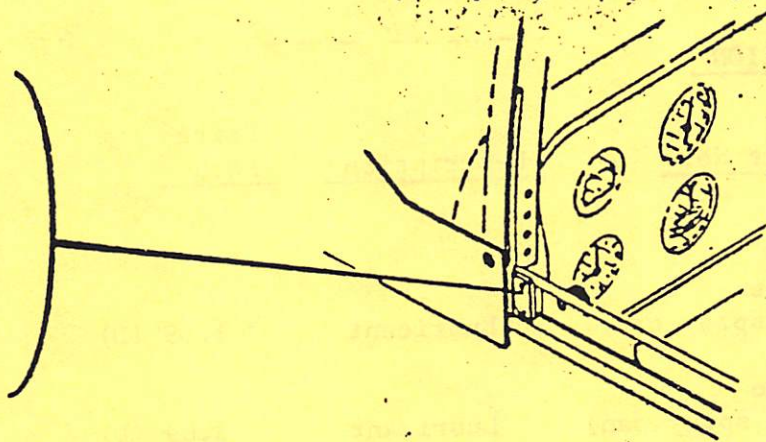
6. Aircraft delivered from the factory after April 21, 1970 have the teflon glide material secured in the outer tracks with a roll pin, Essna Part No. 52-012-062-0500, inserted at the forward end of each channel. Aircraft delivered prior to April 21, 1970 can be modified in the field to incorporate this improvement. A Canopy Track Drill Jig, Part No. ST-1074, is available which may be used to assist in locating and drilling holes for field installation of the roll pins. Use of Tool No. ST-1074 is illustrated below.

Insert tool into outer track, rotate and slide forward against cowl deck. Drill (2) 1/16" diameter holes. Remove tool. Install roll pins. Repeat operation on opposite track.

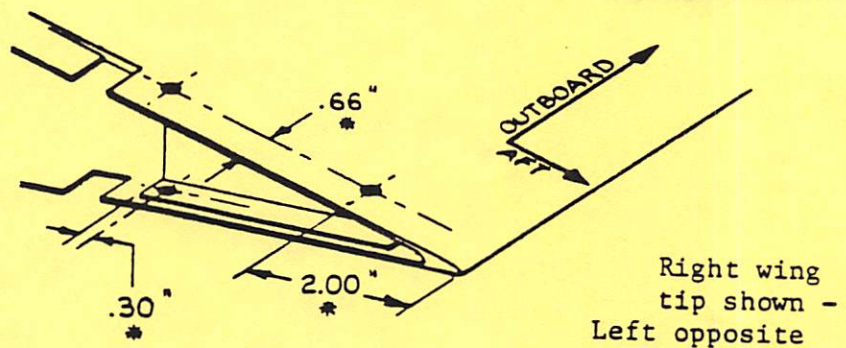
Field reports indicate that on certain aircraft the aluminum stiffening rib located inside of the aft inboard edge of the wing tip may be subject to delamination from the inside of the wing tip. To insure the integrity of the stiffening rib, it is recommended that the attachment of the stiffening rib to the wing tip be inspected for delamination on Aircraft AAL-0001 through AAL-0440 at each scheduled inspection unless the aircraft has been modified in accordance with Item 2 below.

1. If delamination has taken place, the rib must be resecured to the inner surface of the wing tip with at least two layers of 10 oz. glass cloth and epoxy resin.
2. To eliminate possible future delamination of the stiffening rib to the wing tip joint caused by wing tip flexing, it is recommended that three (3) flush rivets be installed in each wing tip as shown below.

Drill .136/.139 inch diameter hole, countersink 100° X .205 inch diameter. Install Avex "pop" rivet #1604-0412 or equivalent three places each wing tip.

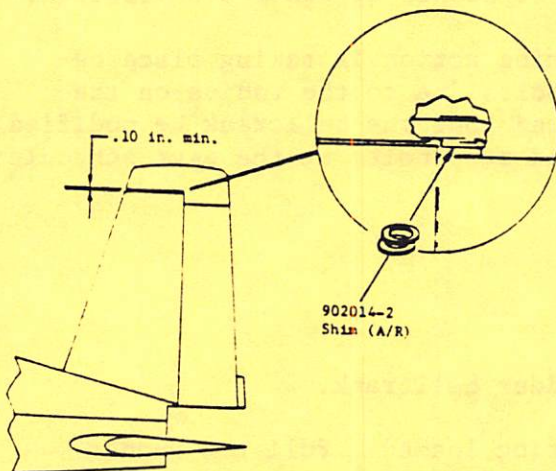
Figure 2. Rudder Tip-Fin Clearance.

4. Prior to installation of the rudder bellcrank, check the clearance between the rudder tip and fin. Minimum clearance is 0.10 inch as shown on figure 2. If clearance is less than 0.10 inch, install shims part number 902014-2 as required. Lubricate the rudder bearings, as required, with Aeroshell grease #6 or equivalent per MIL-G-7711.

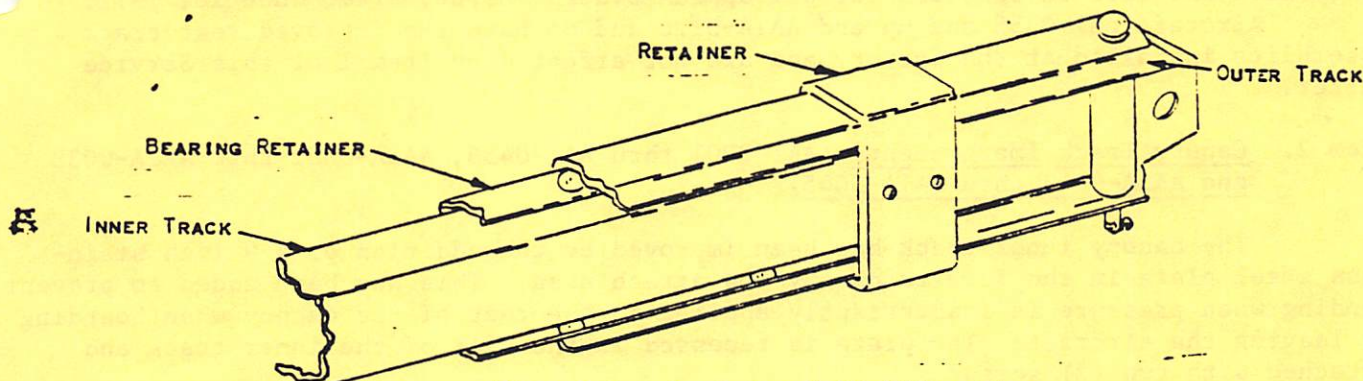
Figure 1. Seat Track Modification

Improved seat track assemblies have been developed which incorporate retainers (3 per seat), riveted to the ends of the inner track and enclosing the outer track. The retainers prevent the outer track from springing and twisting when excessive aft loads are exerted against the seat back (see figure 1).

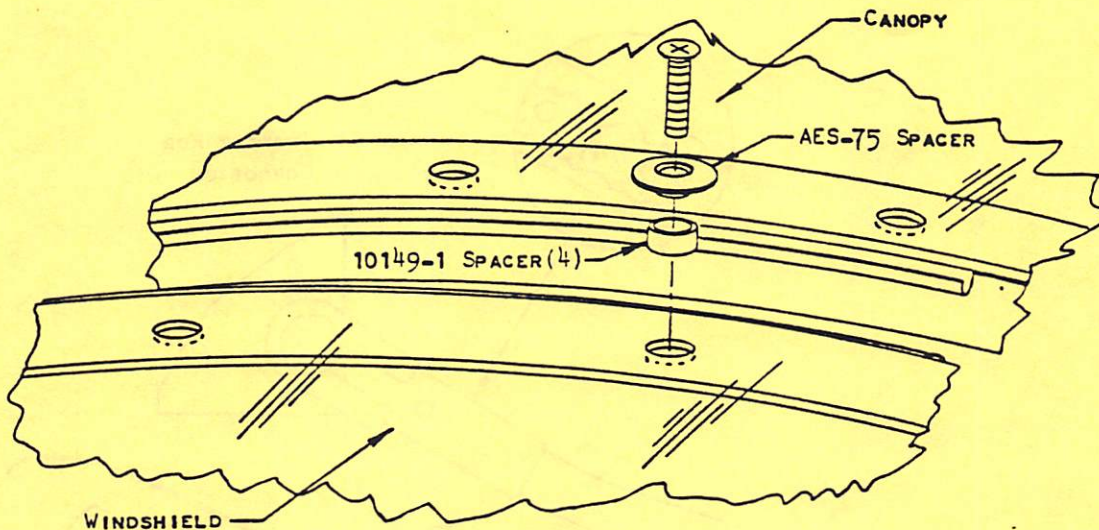
Figure 2. Canopy & Windshield Hardware Improvement

Improvements in the windshield/canopy hardware have been made which provide better sealing of the canopy to the windshield by preventing movement of the bows when latching the canopy. The improved hardware consists of four (4) spacers, part no. 10149-1 which are installed in the two top holes of the windshield and the two top holes of the canopy only (see figure 2).

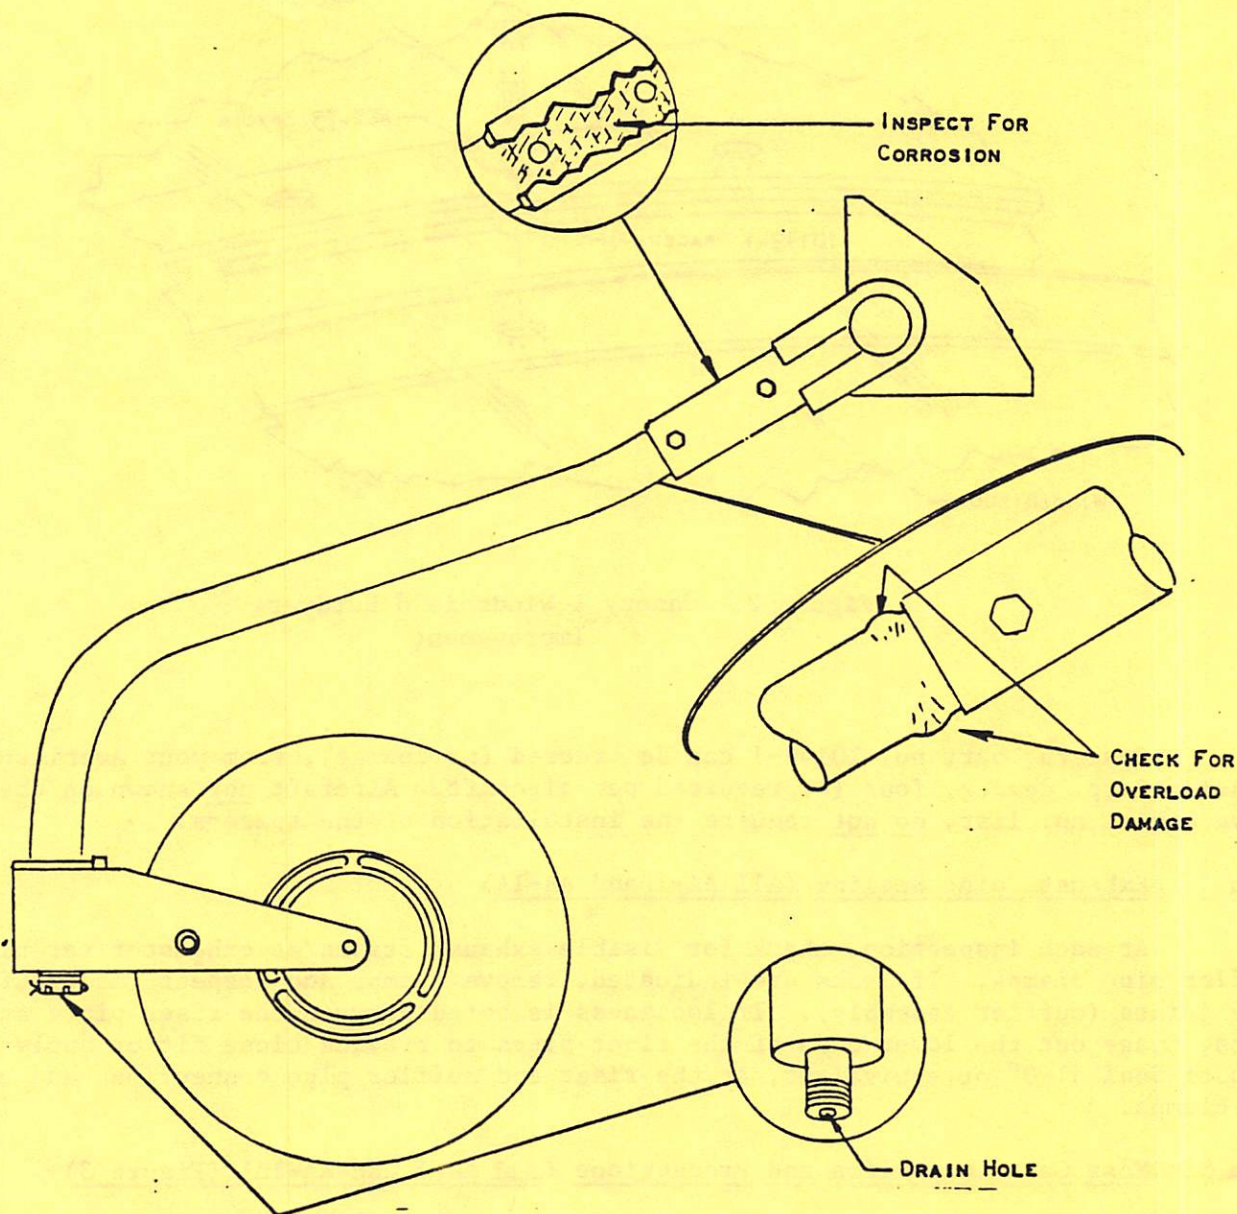
Figure 3. Nose Gear Inspection

- a. Loosen nose gear boot and inspect strut for evidence of overload damage in the area shown:
- b. Check strut for looseness in torque tube yoke. If loose, replace bolts (NAS464P6A28). If new bolts do not eliminate looseness, ream to next larger size NAS bolt (NAS464P7 maximum).
- c. Check drain hole at lower end of strut to insure it is open. One method is by running a .125" drill bit through the hole to clean out any foreign material that may inhibit draining.
- d. Remove strut at each annual inspection and inspect for corrosion in the strut to torque tube yoke joint. Reseal per item 6.

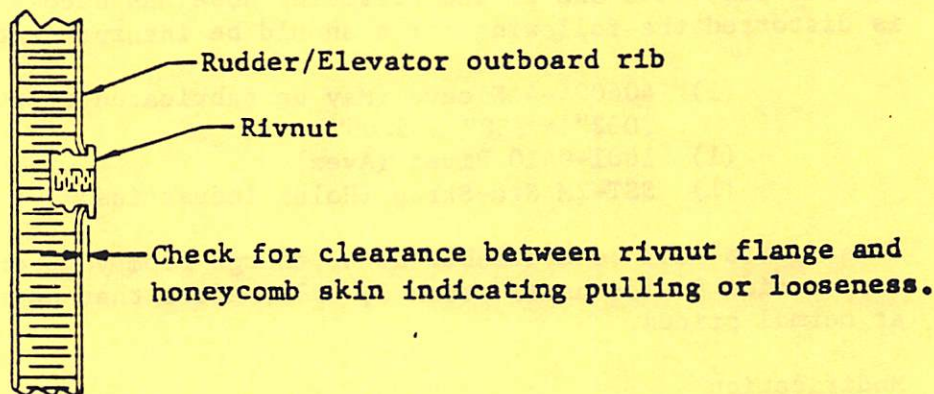
Figure 1. Rudder/Elevator Rivnut Inspection

At each scheduled inspection, it is recommended that the elevator/rudder tip be inspected for looseness. If looseness is noted, remove the elevator/rudder tip and tip-to-elevator rib assemblies and inspect the rivnut in the outboard/top rib for security of installation. Evidence of pulling will be indicated by clearance between the rivnut flange and the honeycomb skin (See Figure 1.)

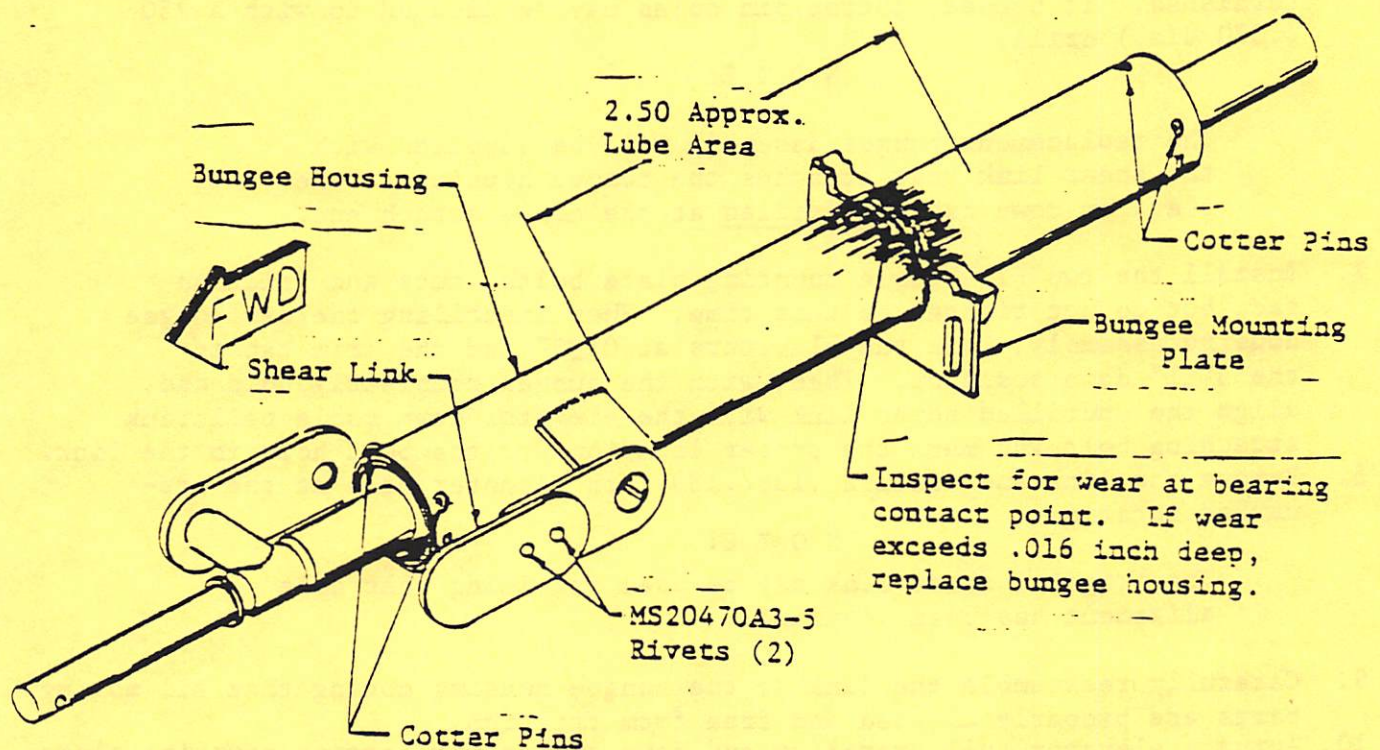
Figure 1. Bungee Assembly

Field reports indicate that on aircraft with 500 or more hours, the bungee housing outer surface may show excessive wear at the support bearing, or the rivets, which secure the shear link, may have become loose (See Figure 1).

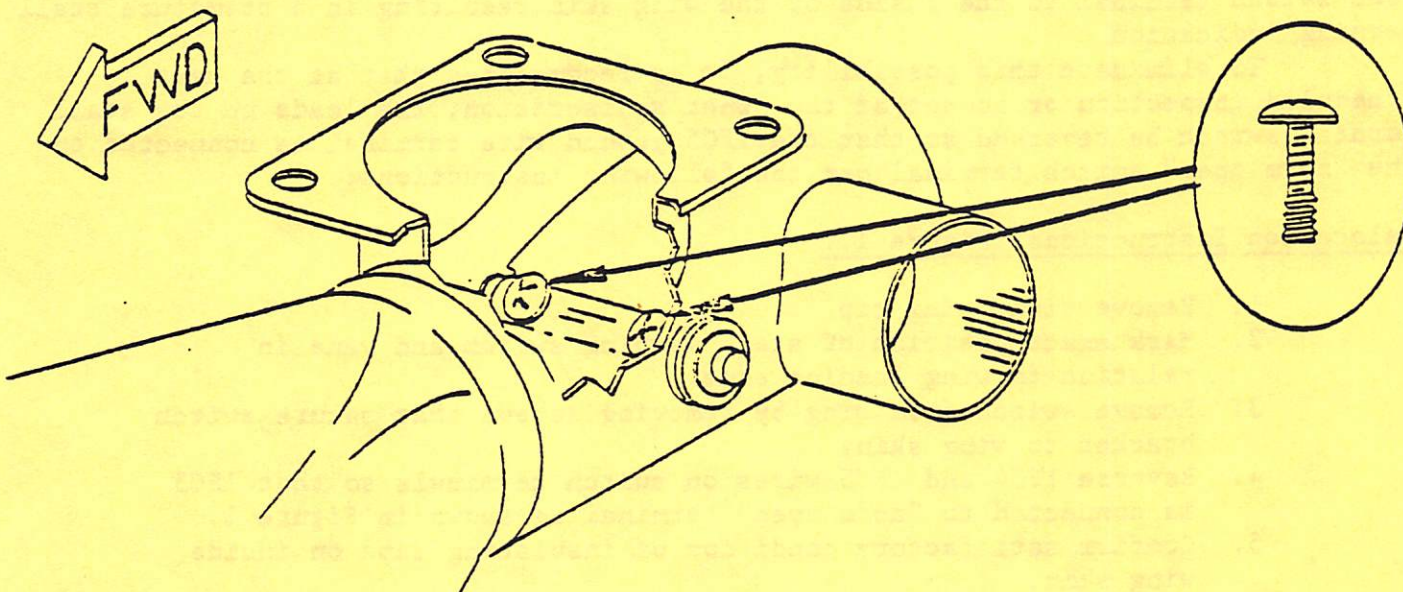
Figure 1. Carburetor Air Valve Screw Inspection

Field reports indicate that certain aircraft may have the screws that secure the carburetor air box alternate air valve to the shaft worn under the heads.

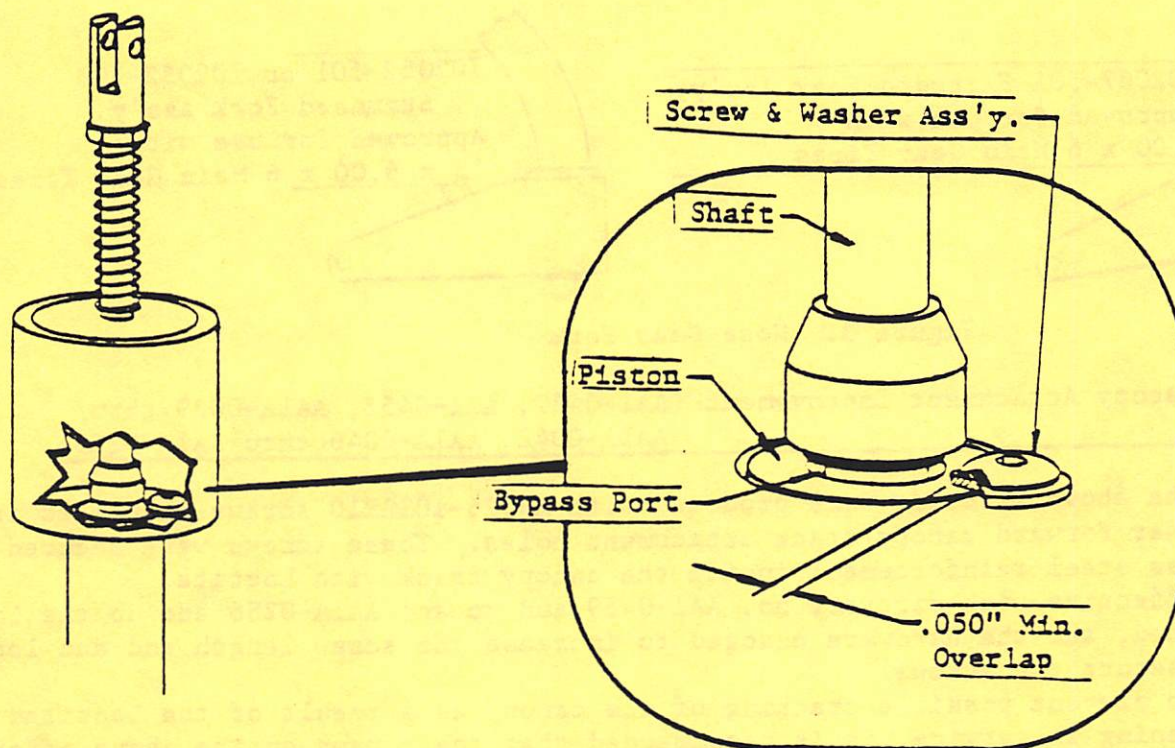
Figure 2. Master Cylinder

Note that this possible defect applies only to the reservoir type master cylinders installed on the pilot's side of the aircraft and does not affect the co-pilot's side.

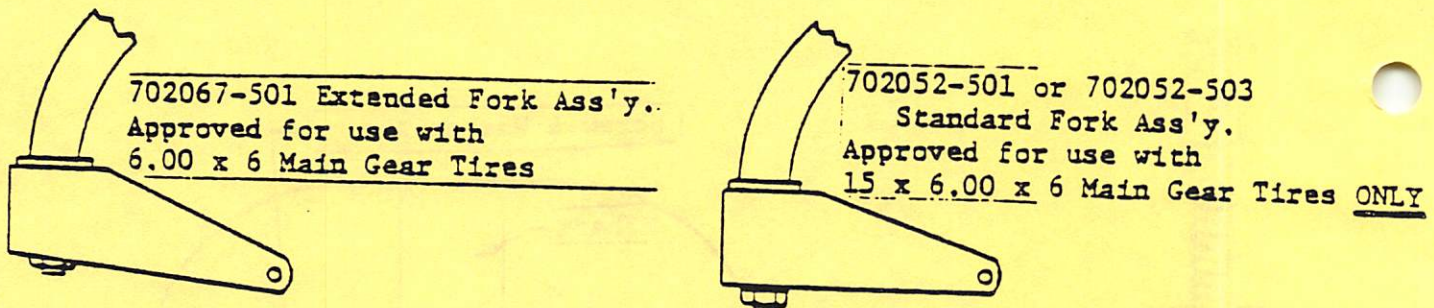
Figure 3. Nose Gear Fork

Failure to install part no. 702067-501 extended fork assembly when installing 6.00 x 6 main gear tires, results in reduced propeller clearance and is not approved. We cannot be responsible for any aircraft operated in this condition. Figure 3 below illustrates the different fork assemblies to assist you in identifying these components.

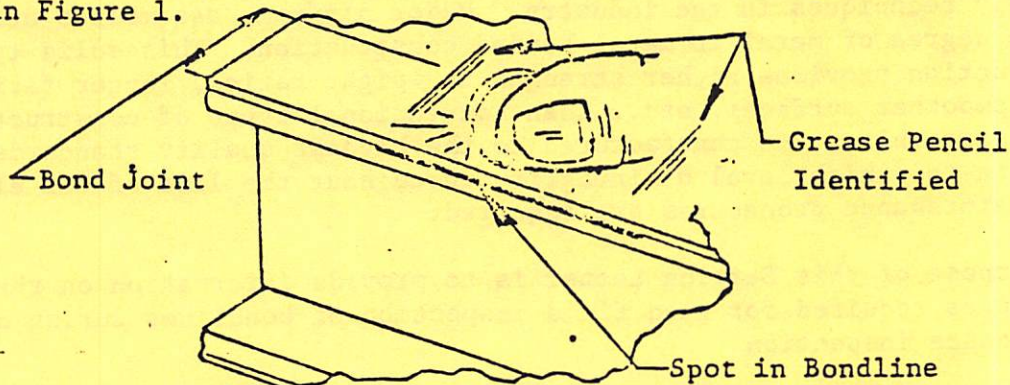
Figure 1. Identifying Suspect Areas

Carefully scan the edges of all joints in a well lighted hangar or outside in daylight to determine the existence of hairline cracks between two layers of bonded metal. Figure 1 shows the appearance of this condition. Identify the location of any cracks with a grease pencil as shown in Figure 1.

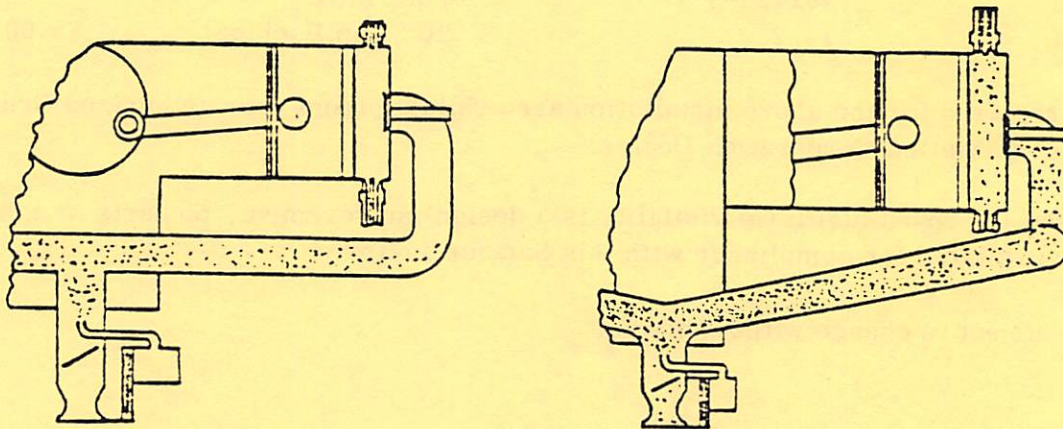
Intake Manifold Schematic

The schematics of the intake manifold are illustrating what is happening when the fuel mixture is too rich. The heavy ends of the fuel that contain tetra ethyl lead (T.E.L.) revert back to a solid once they come in contact with a cold manifold. These lead globules build up, and eventually work their way into the cylinder and find their way to the spark plug, causing the spark plug to foul.
