SUMMARY OF AA-1 SERVICE LETTERS

SERVICE

L
E
T
T
E
R

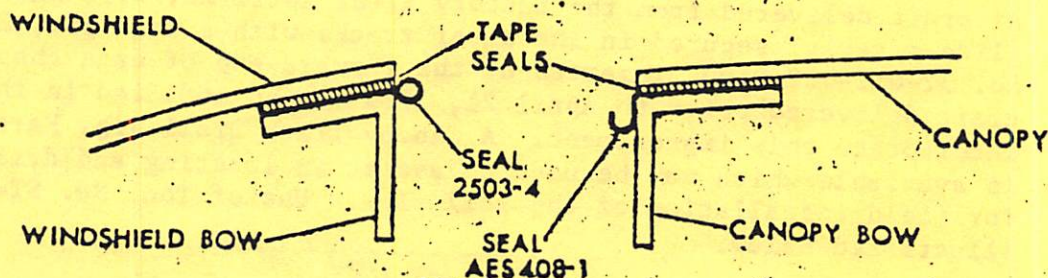
Item 3 - Canopy - Windshield Seals

Improved seals at the canopy-windshield junction have been installed on Aircraft AAL-0262 and up and are being supplied for all spares requirements for earlier aircraft. The new windshield seal, Part No. 2503-4, and canopy seal, Part No. AES408-1, are positioned between the plexiglas tape seal and the windshield-canopy bow as illustrated below.

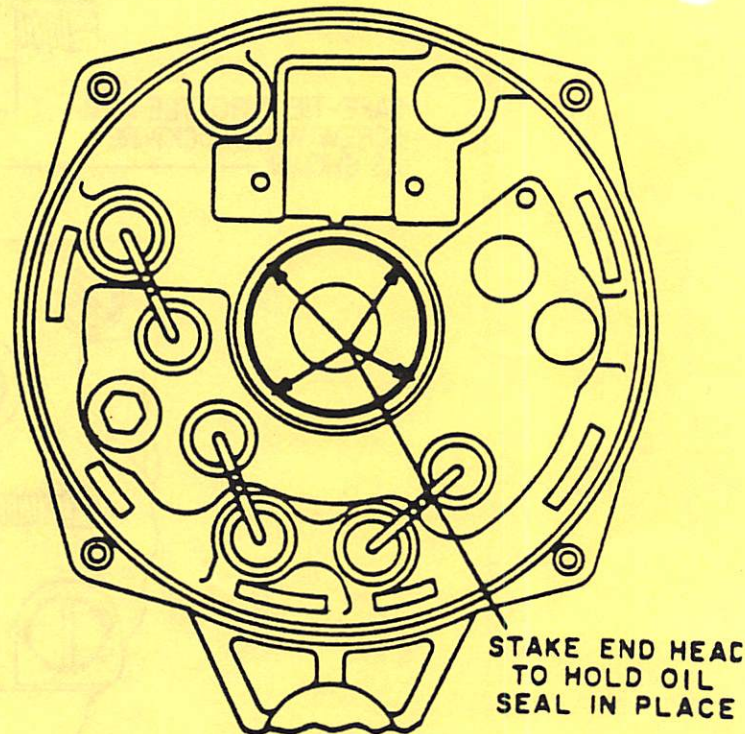
Figure 1

It has come to our attention that, under certain conditions, the oil seal can vibrate loose and work out of the end head.

When a loose slip ring end oil seal is encountered, the alternator should be disassembled, the oil seal inspected for damage, and, if usable, reinstalled and staked in place. If the oil seal is damaged a new one should be installed and staked in place.

Staking should be done, using a small staking tool such as a chisel or punch, in a minimum of 4 locations equally spaced around the oil seal as shown in Figure 1.

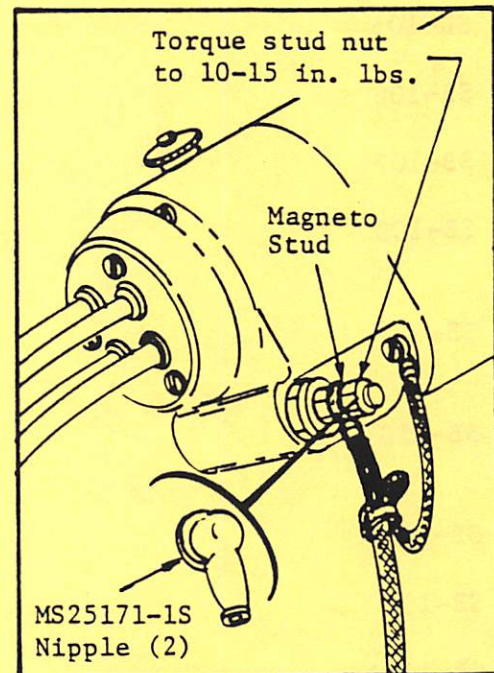
Figure 1. Magneto Lead Isolation

It has been reported that during a routine inspection, the magneto ground lead shielding, which is attached to the magneto housing, was found improperly secured and contacted the magneto stud causing a dead magneto. To prevent the possibility of this happening, we recommend that two nipples, part no. MS25171-1S, be installed at next scheduled inspection, or sooner at the owner's discretion.

1. Disconnect the leads from each magneto stud.
 2. Slide a nipple (MS25171-1S) over each lead and reconnect leads to magneto studs.
- NOTE: Torque the magneto stud nuts to 10-15 in. lbs. Do not over torque as stud may be pulled from capacitor.
3. Slide the nipple over the magneto studs.
 4. The shielding on the magneto lead is pulled back, looped and tied as shown on figure 1. Be sure the loop is pulled back and tied securely Loop must be outside of nipple.
 5. Run up engine and check for normal magneto and switch operation.

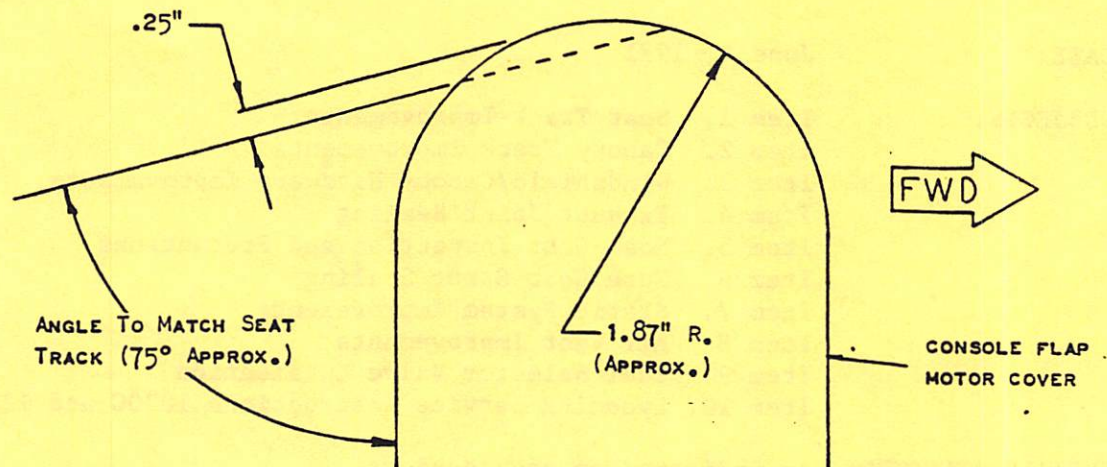
When installing 102323-505 inboard track assembly on aircraft serials AAL-0001 thru AAL-0457 and AALA-0001 thru AALA-0125, a slight interference will be noted between the forward retainer on the co-pilot inboard seat track and the flap motor cover area of the console. Modify the console interference area using a hot iron (225°F), as shown below. (Place a piece of cloth between iron and console to prevent sticking).

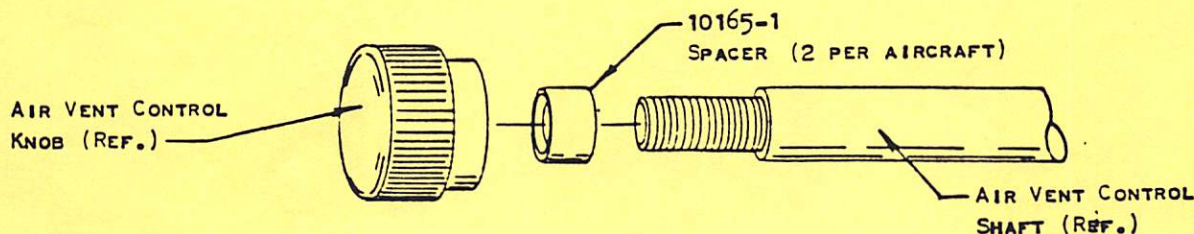
Figure 5. Air Vent Control Shaft Spacer

To provide more control rod travel toward the closed position, a spacer, part no. 10165-1, has been added on current production aircraft, between the shaft shoulder and the control knob. This provides 1/4 inch more rod travel and assures the valve fully closing when properly adjusted. Spacer, part no. 10165-1 can be ordered (no charge), from your authorized American Aviation Corporation dealer.

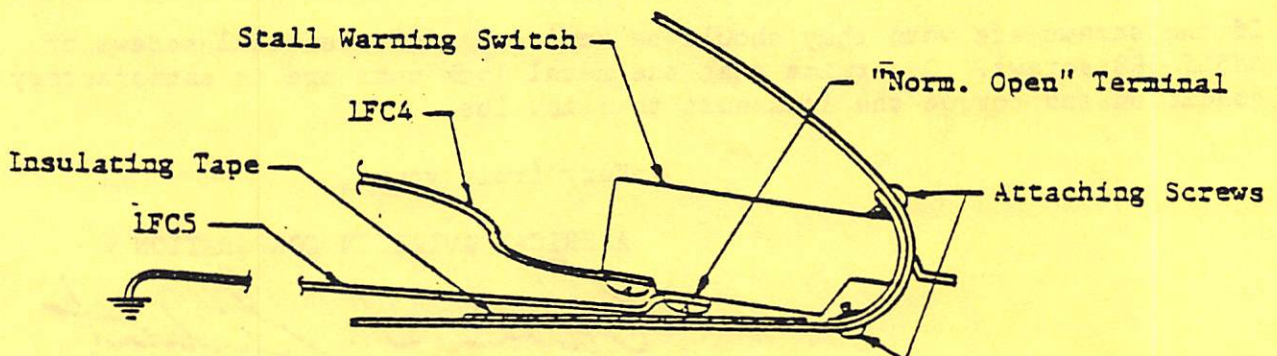
Figure 1. Stall Warning Wire Relocation

If switch is not relocated in exact same position as removed, the aircraft must be flight tested to confirm that stall warning horn sounds at 5-10 mph above stall speed at gross weight flaps up and flaps down.

Aircraft nos. AALA-0280 and up have the wire terminals connected as shown in Figure 1 and are not affected by this item.

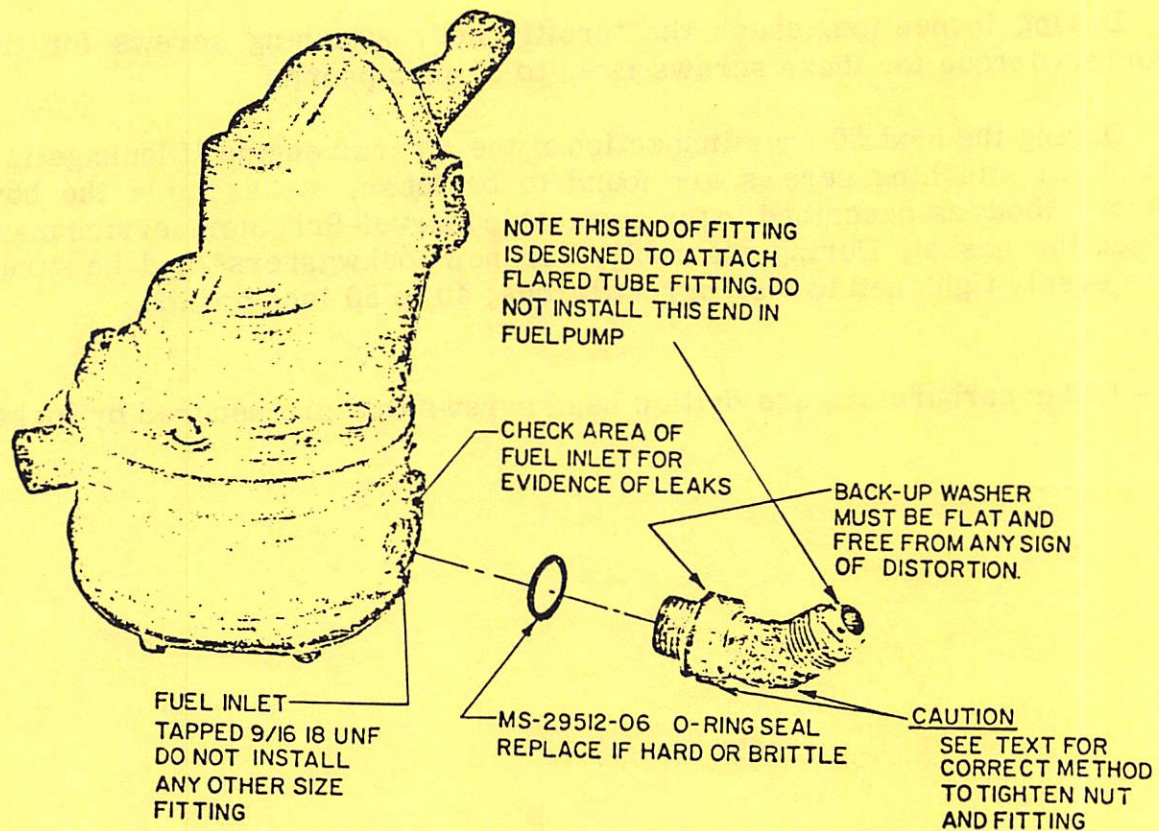
Figure 1. Diaphragm Fuel Pump Showing Inlet Boss, Seal and Fitting

3. Carefully examine the o-ring seal and metal back-up washer on the fitting. Determine if the seal is hard or brittle from ageing or damaged from improper assembly. Likewise, examine the back-up washer on the fitting to determine if it is flat and free from distortion. Also examine the chamfered o-ring seat and the threads in the fuel pump inlet boss for evidence of damage. From the condition of these parts the cause of leakage likely can be determined.

4. Any of these parts that are damaged must be discarded, even the fuel pump if the inlet threads are damaged or the chamfer nicked.
