GRUMMAN AMERICAN AVIATION
CORPORATION
SAVANNAH, GEORGIA

STANDARD REPAIR MANUAL

MODEL ALL LIGHT A/C : REPORT NO. LIÁ S.R. 002

REPORT DATE: FEB. 1, 1978

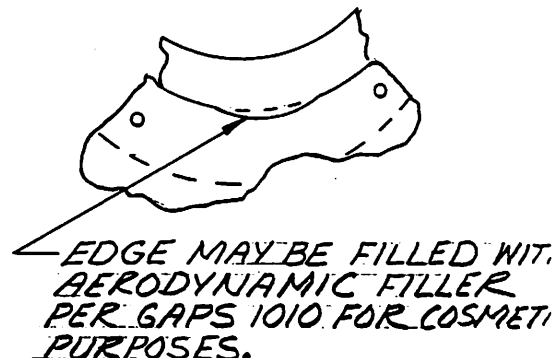
Condition 1. Gouge or tear up to .12 in length:

File out damaged area and blend to skin edge over approximately 1.0" length.
